ClassNK PSC Bulletin

Date:	26 February 2016
No:	NK-PSC-06
Attachment	No / Yes : page(s)

Fixed Gas Fire-Extinguishing Systems

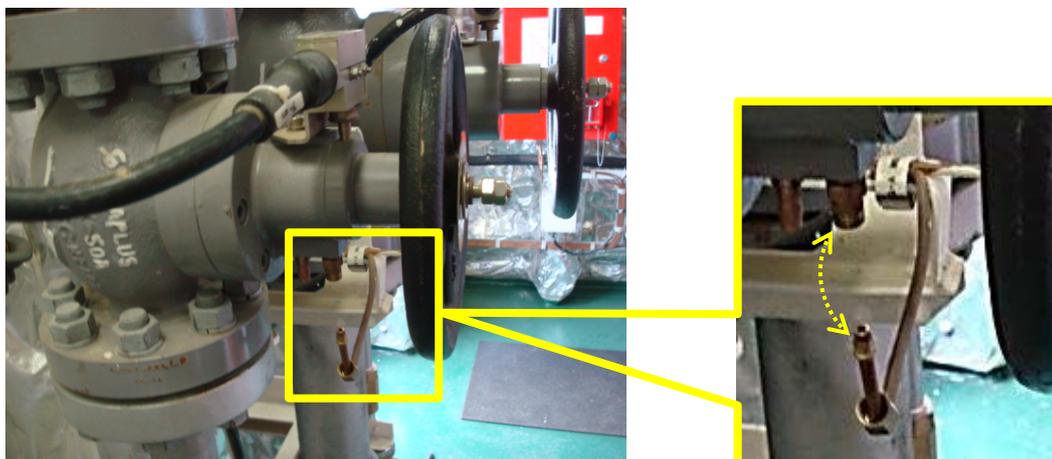
(1) Example of dis-connected pilot line for CO2 discharge valve

<Required action> After the service supplier's inspection/maintenance, special care should be taken by ship's crew to check and ensure that all pilot lines connections are properly in place.

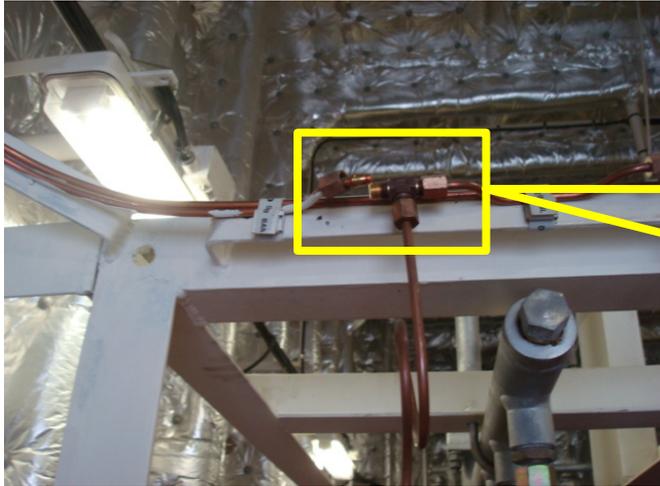
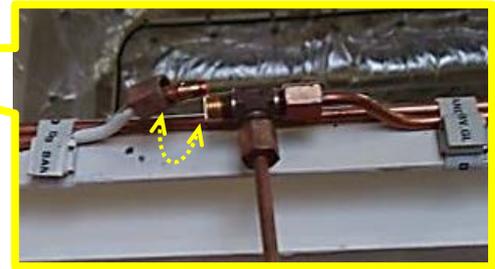
(2) Example of dis-connected pilot line for CO2 cylinders operation
