ClassNK PSC Bulletin

Date:	19 September 2017
No:	NK-PSC-11
Attachment	No / Yes: _____ page(s)

Cable penetration of ECDIS

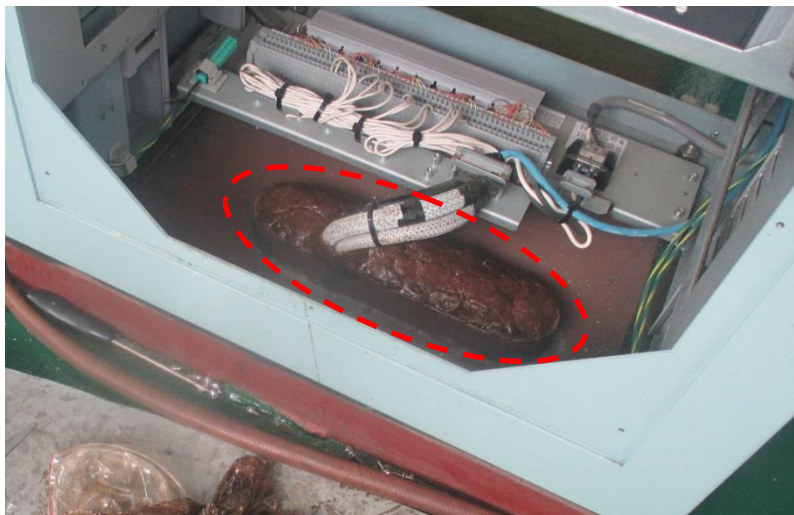
During recent PSC inspections in China, it has been reported that PSC officers have pointed out that openings for cable penetration of ECDIS (navigation bridge deck) were not filled up (sealed).

The cause of this deficiency was due to the fact that although an opening was made for cable penetration on the navigation bridge deck when installing ECDIS while the vessel was in service, no measures were taken to ensure the fire integrity of the navigation bridge deck after such installation (such as sealing the opening with suitable non-combustible material).

Cable penetration in ECDIS console box after rectification
(Sealing the opening with non-combustible material)

In this regard, please confirm once again whether fire integrity is ensured or not at cable penetration openings made for the installation of ECDIS.
