ClassNK PSC Bulletin

Date:	26 October 2018
No:	NK-PSC-16
Attachment	No / Yes — page(s)

Fire main/CO₂ lines on deck

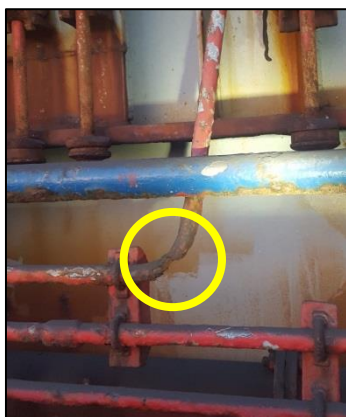
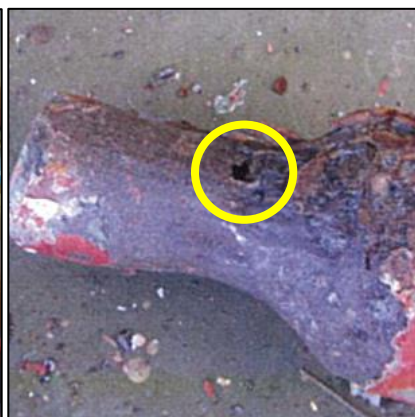
Fire main/CO₂ lines on deck are leaking/corroded.

Corroded CO₂ lines

Given the above situation, it is recommended that not only operation tests of fire pumps but also a visual check of the fire main and CO₂ lines on deck are to be carried out at appropriate intervals for all ships in your fleet. In case any deficiencies are found during such checking, please take appropriate measures to address the deficiencies, accordingly, and then arrange for the conduct of an Occasional Survey.

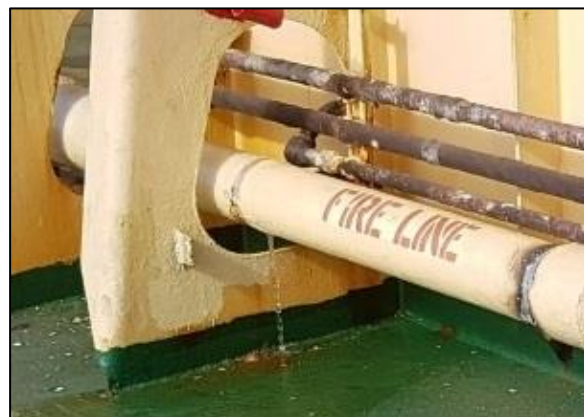
Leakage from fire main
