ClassNK PSC Bulletin

Date:	18 September, 2024
No:	NK-PSC-25
Attachment	No / Yes: _____ page(s)

Deficiency relating to stern light

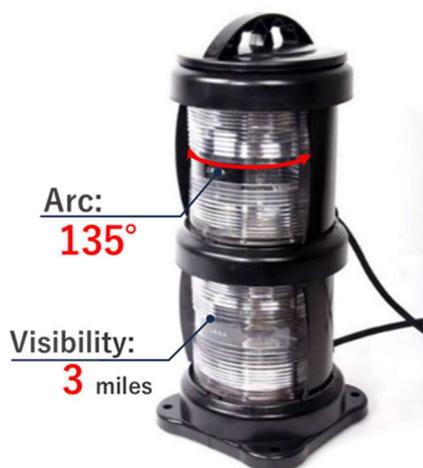
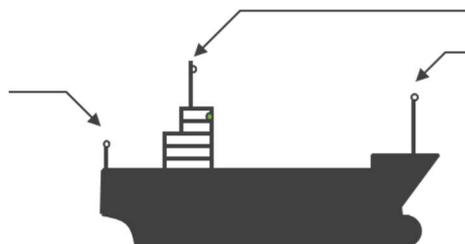
Stern light

In particular, there are many cases where masthead lights are incorrectly installed at the stern light position. The required visibility and light projection angles of masthead lights differ from those of stern lights.

In some cases, masthead lights are installed at the stern, while stern lights are installed in the masthead position. Given this, a thorough review of the navigation light arrangement across your fleet would be highly appreciated.
