ClassNK PSC Bulletin

Date:	4 August, 2025
No:	NK-PSC-26
Attachment	No / Yes: page(s)

Improper Freefall Lifeboat Hook Reset (SOLAS Chapter III / Reg.20.6.1)

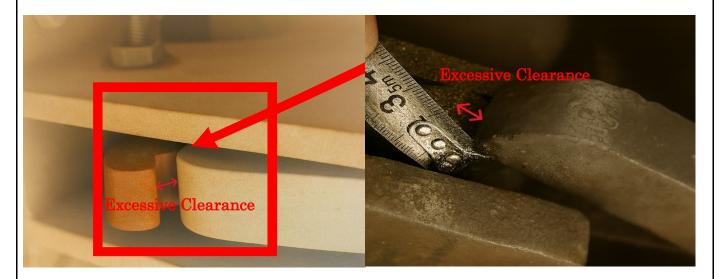
"Free fall lifeboat release mechanism not correctly reset."

"Freefall lifeboat release defective."

Clearance between "freefall lifeboat hook end" and "lock block piece" has been frequently pointed out by PSCOs as improper reset condition recently.

Hook reset condition is to be confirmed during "weekly inspection" by crew as per SOLAS III/Reg.20.6.1. Nevertheless, it has been reported the improper reset due to familiarization of reset procedures as per the Maker's operational manual after routine onboard release test, as well as lack of knowledge for identifying deficiency during weekly inspection by crew.

Example Photos of Excessive Clearance Pointed Out by PSC

The management company is to take proper preventive measures for avoiding such deficiency. Sufficient training is to be carried out on board for understanding the correct procedures of hook reset and weekly inspection. If crew has doubt on clearance criteria, the management company is to confirm with the Maker of its authorized service provider for instructions.
