Risk Assessment related to the Safe Escape from a Car Carrier

1. Introduction

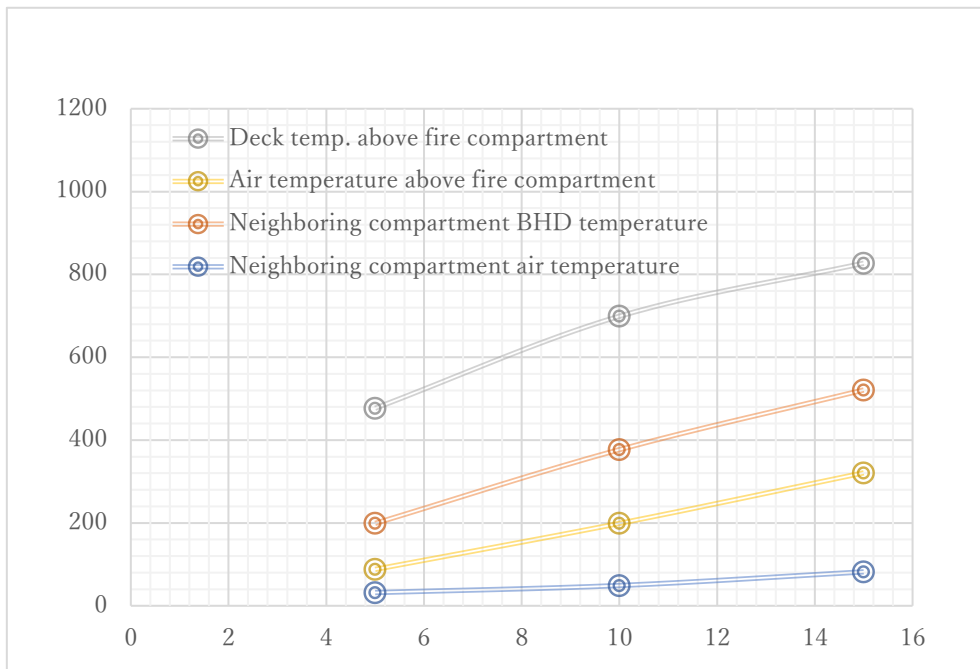
Figure 1 Situation within compartment adjacent to compartment where fire breakouts*

The temperature assumed inside a compartment adjacent to that where a fire breaks out as well as the temperature assumed for deck bulkhead in said compartment and the ignition time for combustibles located in said compartment are shown in Fig. 1.

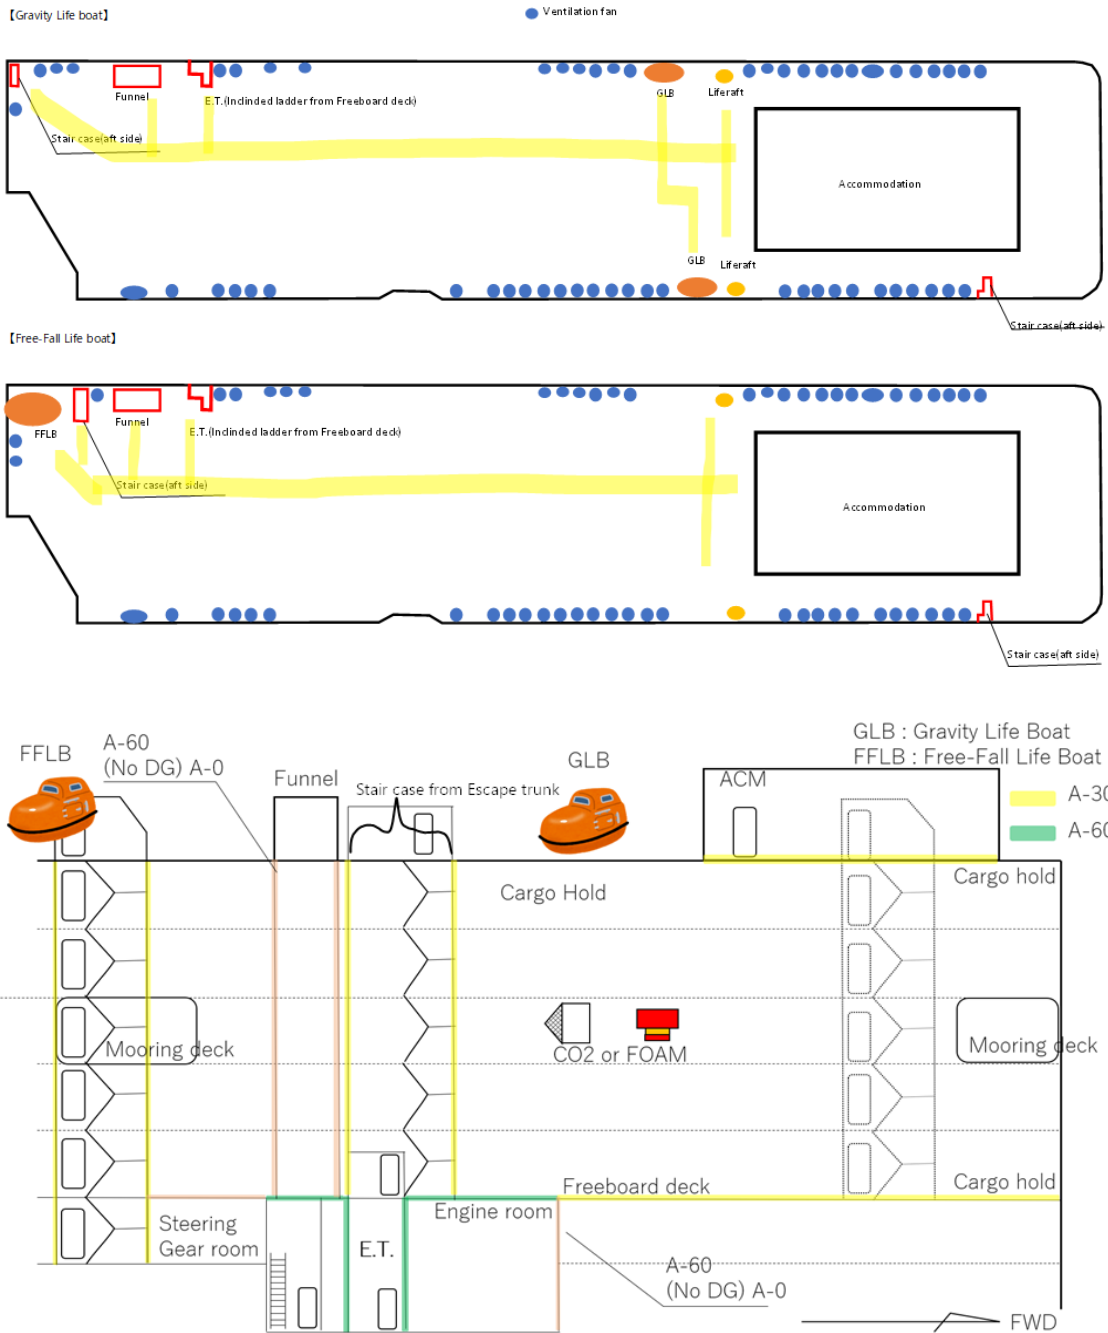
The following two types of ship structures were assumed for risk assessment: a PCC equipped with a gravity-descent lifeboat and a PCC equipped with a free-fall lifeboat.

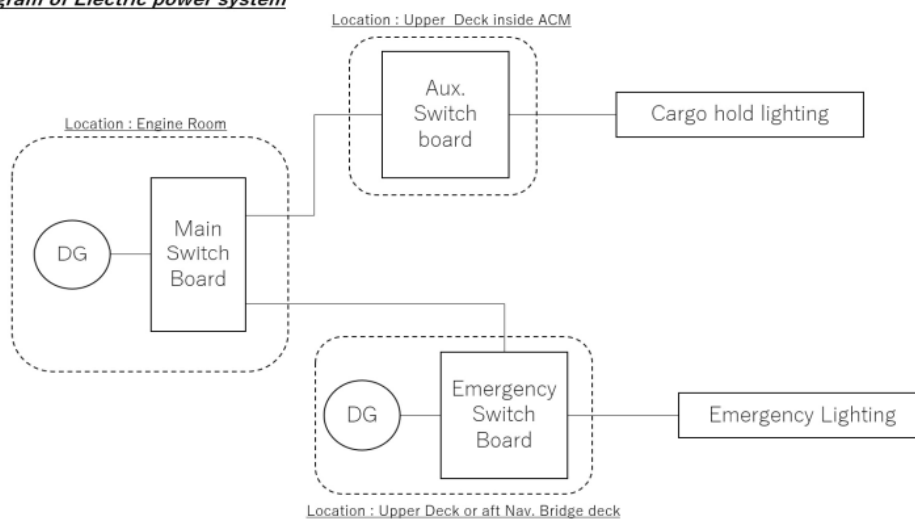
Wiring diagram of Electric power system

Since the ship's crew may be required to abandon ship at night or other times when visibility might be poor, the failure of lighting systems (main, emergency or both) would likely increase the chance of injury occurring during escape. This risk assessment evaluated the risks associated with the loss of such systems due to a cargo hold fire and also examined countermeasures which could be implemented as needed. The scenario is described as BLO-, and its results are given in [Appendix 2](#).

Schematic diagram of lighting system
