# ClassNK PSC Bulletin

No: NK-PSC-13

Closing Arrangements of Cargo Hatch Covers

Damage and/or Wastage of Securing Devices (Cleats) or Cleat Crutches of Cargo Hatch Covers

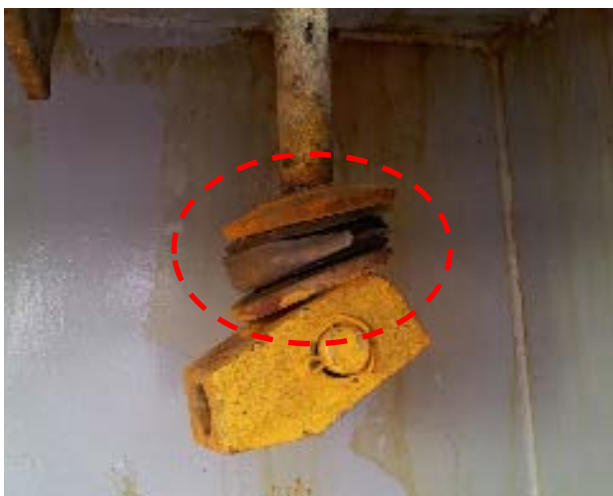
Damaged rubber washer

Given the above situation, it is recommended that visual inspection and maintenance of securing devices between hatch covers and coamings, including crutches, should be carried out for all ships in your fleet at appropriate intervals.

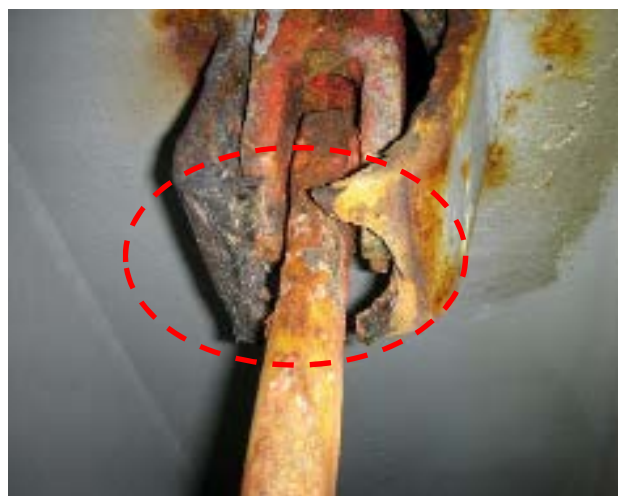
Wastage/damage of securing device crutch
